# Manhole Inspection Summary

Manhole # S29QQ\_021MH

Insp Date: **8/4/08 1:00 PM**

**Location** Address: **2601 FALLS RD**

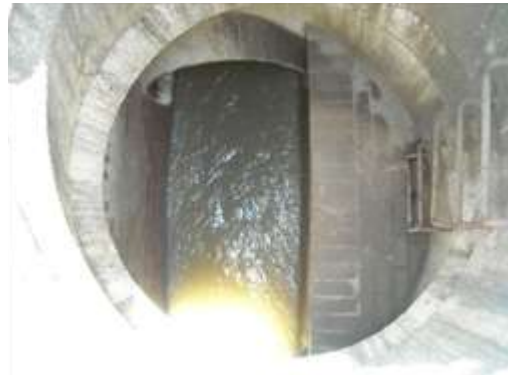
Top View

Bench debris.

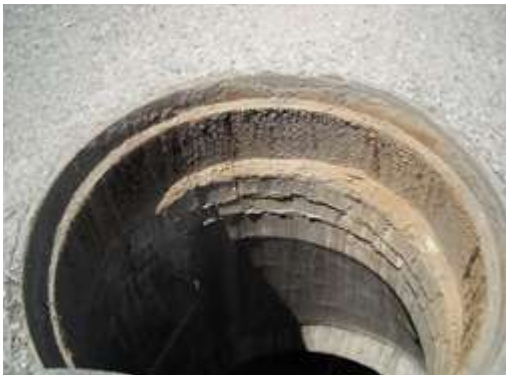
Defect

**Frame** Offset: **2** (in.) Condition: ☐ Sound ☐ Cracked ☒ **Leaks**

Infiltration: ☐ None ☒ **Joint** ☐ Cracks ☐ Mortar ☐ Roots ☐ Wall

Frame leaks. Frame offset. Adjustment infiltration.

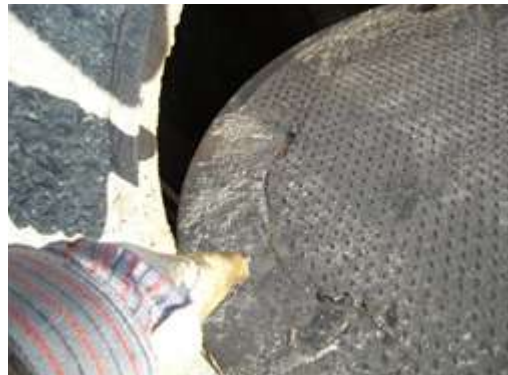
Defect

Type: **Sanitary** Condition: **Cracked** Cover Material: **Cast Iron**

Cracked cover.

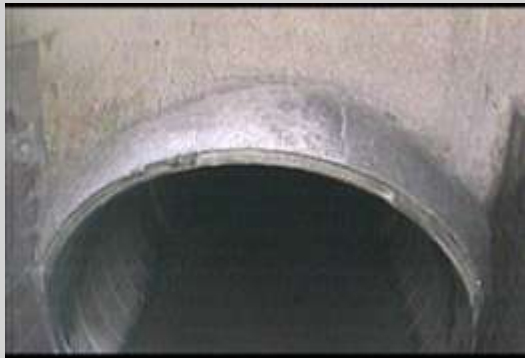
### 36 in. Circular Gravity Sewer Pipe Out @ 12 O'Clock

Infiltration: **Evidence** Pipe Seal Cond: **Unknown**
